BestPractices  
Project Case Study

June 2001

## COMPRESSED AIR SYSTEM MODIFICATIONS IMPROVE EFFICIENCY AT A PLASTICS BLOW MOLDING PLANT

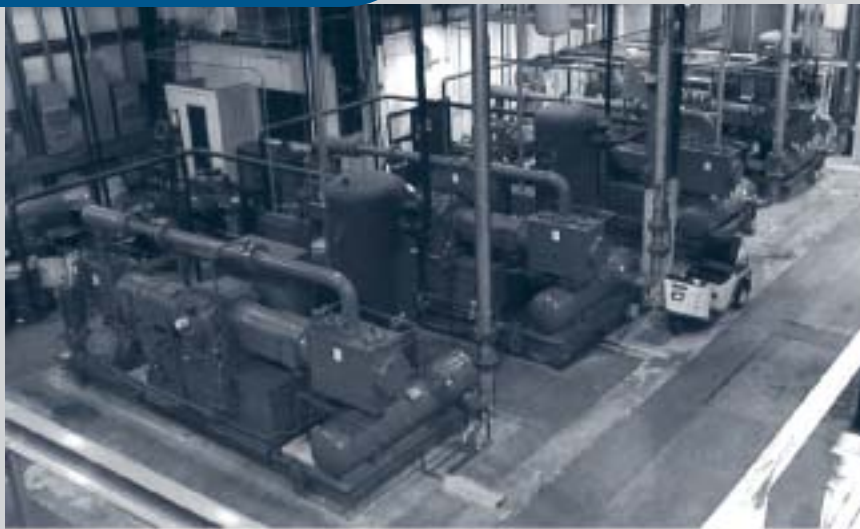
## BOOSTER COMPRESSORS

The next observation was that the three booster compressors had severe internal and external leakage rates around the valve cover plates and unloader valves. This condition prevented the booster compressors from operating efficiently because it caused them to recompress air that had decreased in pressure after it had leaked. In addition, the survey found 367 scfm of low-pressure leaks and 505 scfm of high-pressure leaks in the distribution system that hampered the compressors' ability to stabilize the system pressure.

As soon as the survey was completed, the Enka plant began implementing many of its recommendations. The first order of business was to lower the blow-off set points on the 800-hp centrifugal compressors to 75% of the compressors' load. Next the plant replaced the unloader valves and cover plates around the booster compressors with newer, more advanced models. As recommended, the plant purchased and installed a new dryer with the installation of the third 800-hp centrifugal compressor. Then the plant performed a leak detection and repair project on the largest leaks in its system and switched from cooling the bottlenecks with compressed air to using cabinet coolers. In addition to the recommendations of the NCSU experts, the plant managers decided to replace the solenoid condensation traps with new pneumatic ones because they suspected that the traps were not working properly which may have led to episodes of moisture carry-over into the compressed air system.

In addition, the pneumatic condensation traps eliminated the moisture carry-over problems, which led to more consistent product quality. Due to the lowered pressure and moisture-free air, there was much less wear and tear on the cover plates and rings on the unloader valves. Prior to the project, the cover plates and rings had to be replaced every 2 months. Once the project was complete, these components lasted six times longer, which decreased compressed air maintenance costs by 75%.
